ENERGY ENGINEERING ANALYSIS PROGRAM

ENERGY SURVEYS OF U.S. ARMY

RESERVE CENTERS

FORT SAM HOUSTON, SAN ANTONIO, AUSTIN,
AND HOUSTON, TEXAS

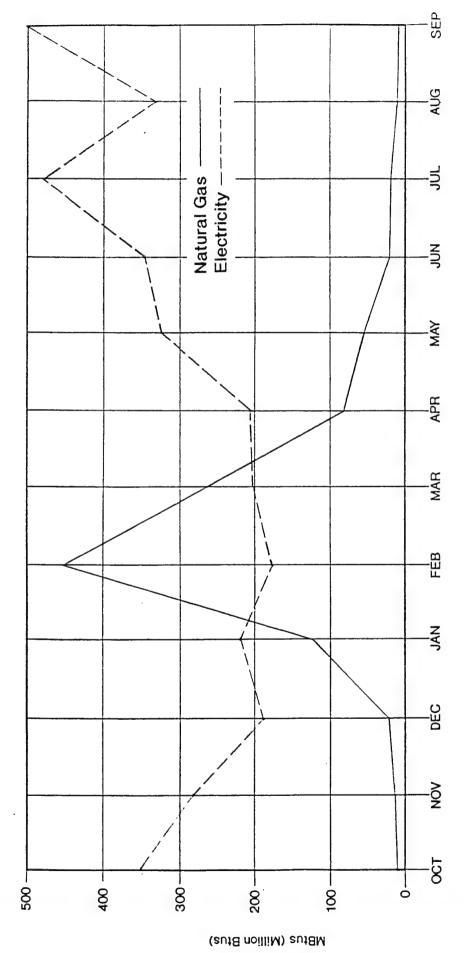
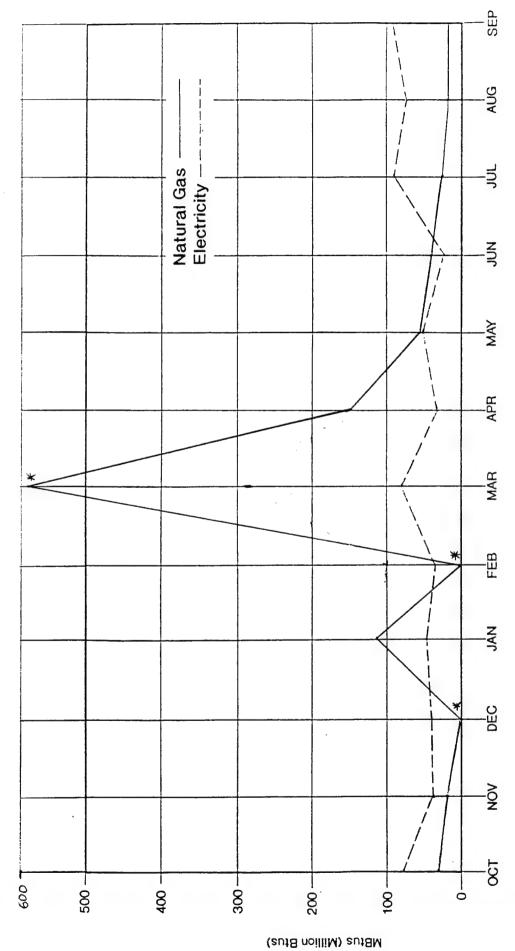
Figure 1 - Energy Consumption (Bldgs. 1520/1521) FY 1988

is consumption for both December and January. The February reading of 100.000 should be of because again the meter was not read. The March reading of 289.300 should be 589.300 and that is for both February and March. Figure 2 - Energy Consumption (Bldg. 1610) FY 1988 *The December reading of 0 was because the gas company failed to read the meter that month and the 113.200 KCF reading for January

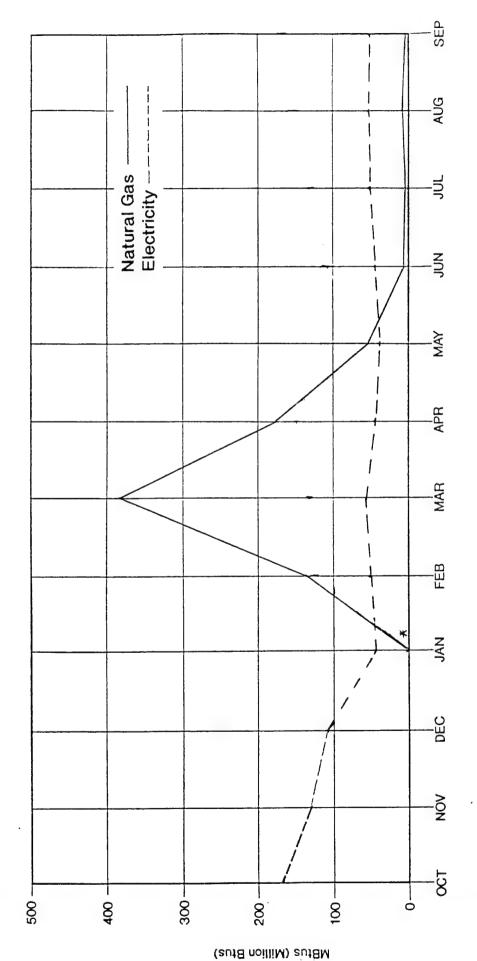
Figure 6 - Energy Consumption (Perimeter Park) FY 1988 *The 0 natural gas readings for October thru January are correct. The office areas are heated with electricity and natural gas is used only for the Warehouse and that are is only heated as necessary.
